WL-TR-97-2053

THIN DENSE CHROME BEARING INSERTION  
PROGRAM

GE AIRCRAFT ENGINES  
ADVANCED ENGINEERING PROGRAMS DEPT  
ONE NEUMANN WAY  
CINCINNATI OH 45215-6301

FINAL REPORT FOR 03/01/92-12/01/96

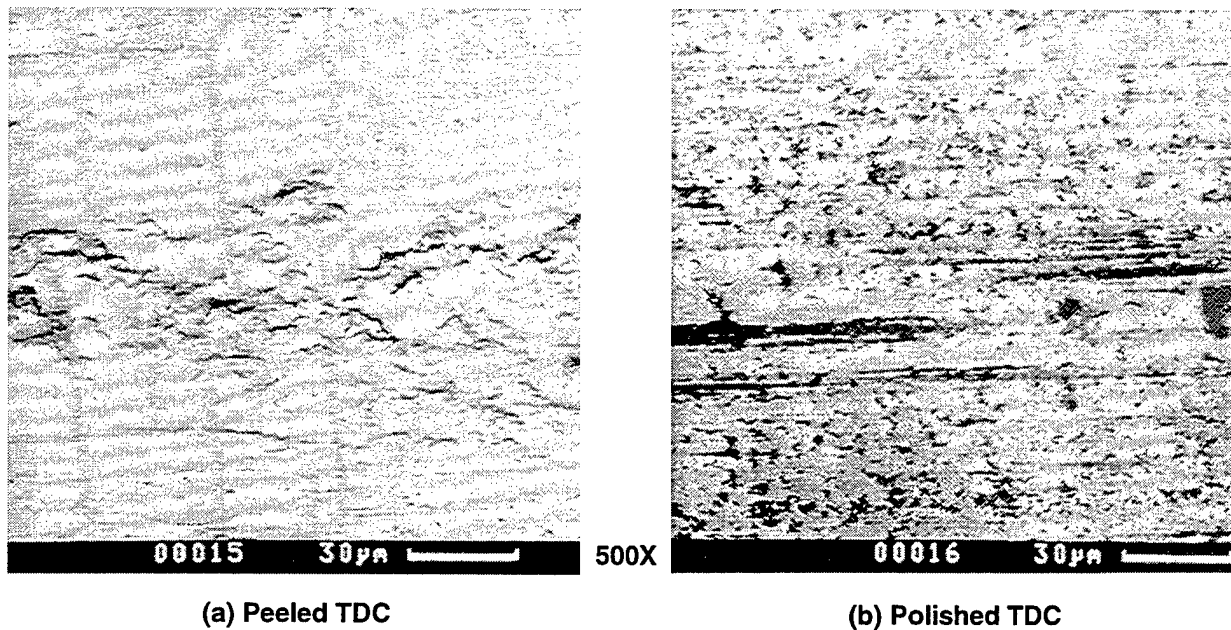
**Figure 134. SEM Backscatter Photos of No. 5 Bearing Inner Race Damage.**  
*TDC coating is susceptible to peeling as evidenced in test of ESN 538-103/4 bearing.*

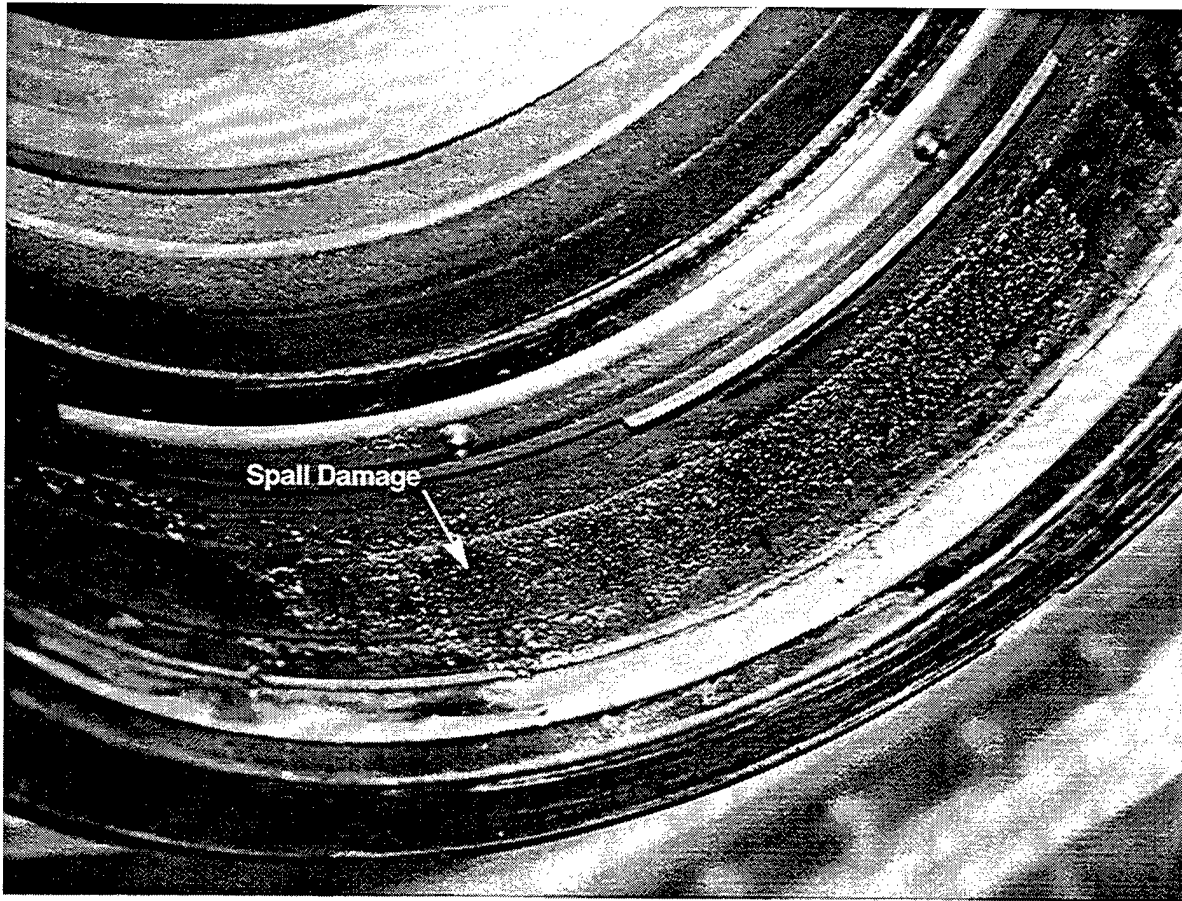
**Figure 136.** Photo of F110-GE-100 ESN 509-716/5 No. 4R Bearing Outer Race Spall.

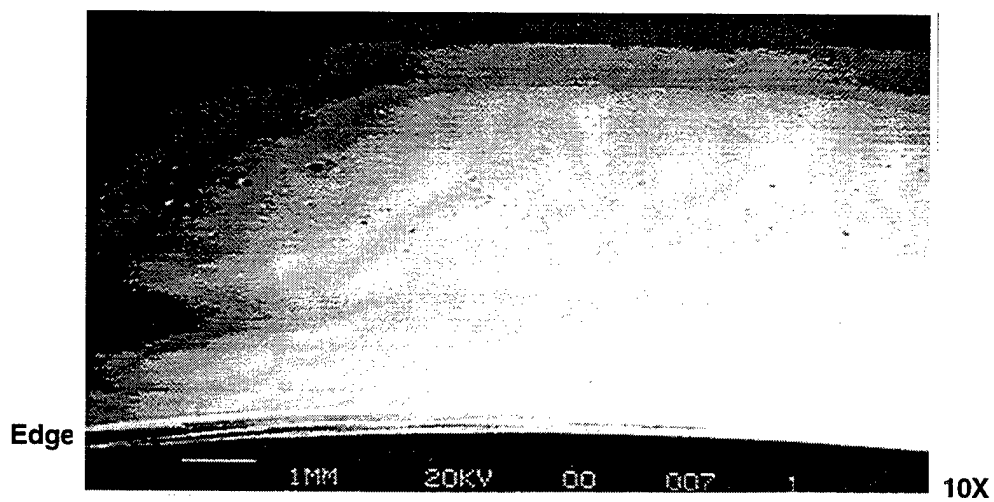
**Figure 137.** SEM Photo of F110-GE-100 ESN 509-716/5 No. 2B Bearing Inner Race.  
*Note band of dimples indicating micropeeling.*

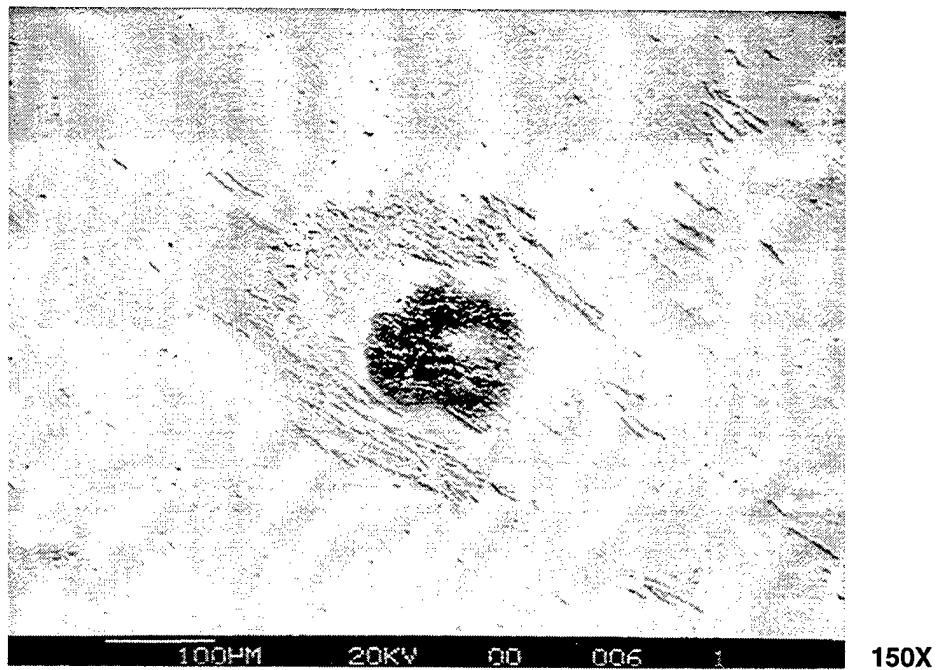
**Figure 139. SEM Backscatter Photo of F110-GE-100 ESN 509-716/5 No. 1R Bearing Inner Race. *TDC micropeeling results in secondary damage.***
